DITCH CREEK DAM

WASHINGTON COUNTY, MISSOURI

MO. 30726

PHASE 1 INSPECTION REPORT NATIONAL DAM SAFETY INSPECTION

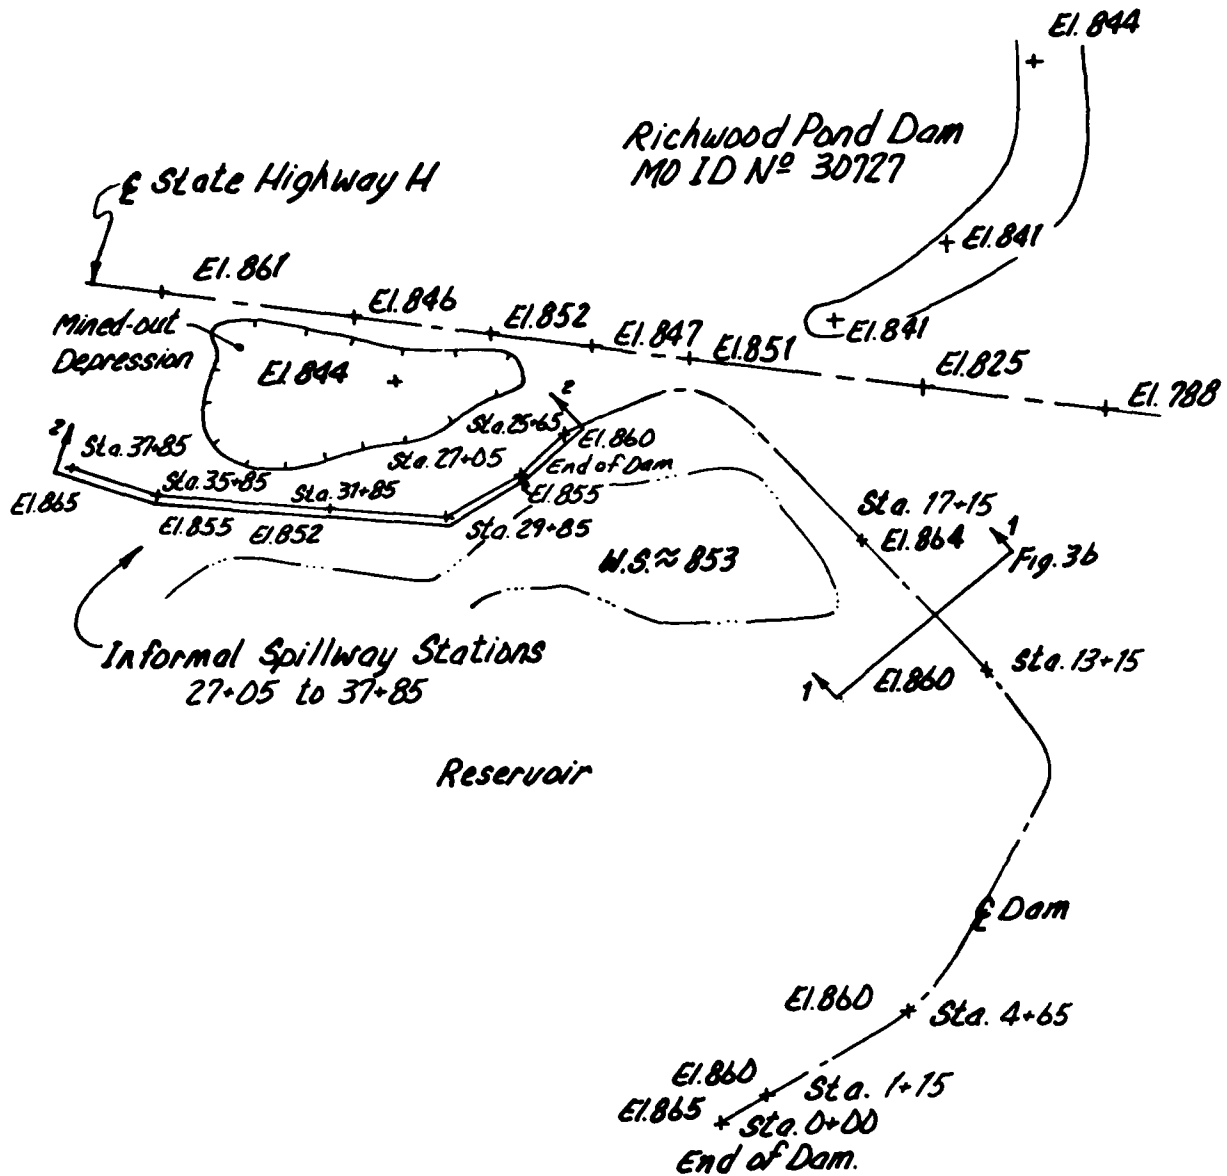
PLAN OF DAM	
DITCH CREEK DAM	
MO 30726	FIG 3A

3. Spillway. There is no formal spillway at this facility. The terminology "informal spillway" has been assigned to the low area to the west of the dam (see Figs. 3a and 3b). This overflow area has a moderate to high erosion potential as the stoney clay residual soil is only moderately vegetated. This soil has been observed to be highly erodible when stripped of vegetation and exposed to flow velocities of over 5 ft/sec.

1. Design and construction of a formal spillway and discharge channel required to pass an appropriate design flood, as an alternate to the present condition where a low area to the west of the left abutment of the dam acts as an informal spillway; consideration should be given to the erodibility of the embankment and spillway.
